Contractor Report ARLCD-CR-84039

SUBMUNITION WARHEAD AND THE XM267
SUBMUNITION TRAINING WARHEAD

William S. Marks
BEI Defense Systems Company, Inc.
11312 South Pipeline Road
Euless, Texas 76039

JANUARY 1985

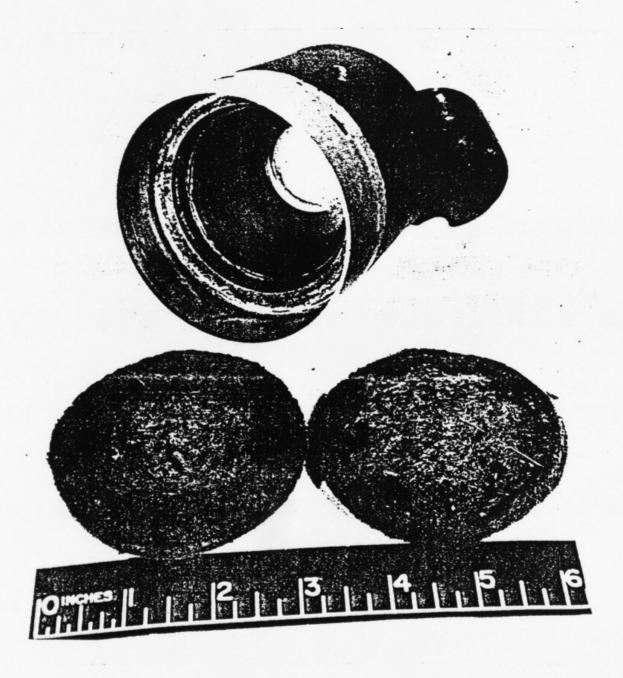
14. The copper cones of the cone and ring assembly, AMRON drawing No. 00022-009, were scored, Each cone was damaged by the rotation of the RAD assembly (fig. 1 (top)).	X	x	×	x

Figure 1. Copper cones scored by rotation RAD assembly (top); felt pad crushed (bottom)

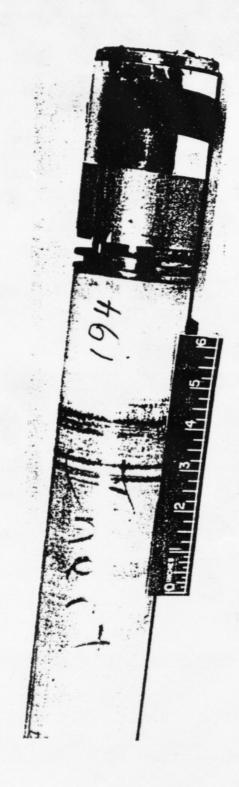
1-inch neck ring signature on rocket motor case assembly showing longitudinal movement within the M67 fiber container Figure 4.

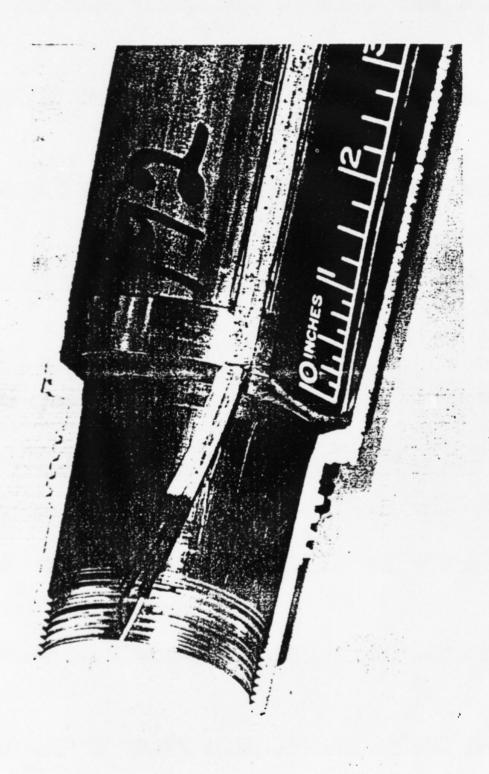
Discrepancies		Round no.			
	191	192	193	194	
11d. Fuze connector cable was partially severed at fuze support, drawing No. 926-0048 (fig. 12).	Sat	X	Sat	Sat	
11e. The fuze connector cable was pulled out of connector cable groove of the warhead case assembly, drawing No. 926-0047 (fig. 13).	X	x	X	X	
11f. The ground connector was pulled out from XM439 fuze pin connector. A short was indicated on the gage.	Sat	Sat	x	Sat	
11g. Fuze support, ARRADCOM drawing No. 0048, was broken.	Sat	x	Sat	Sat

Figure 12. Fuze connector cable partially severed at fuze support

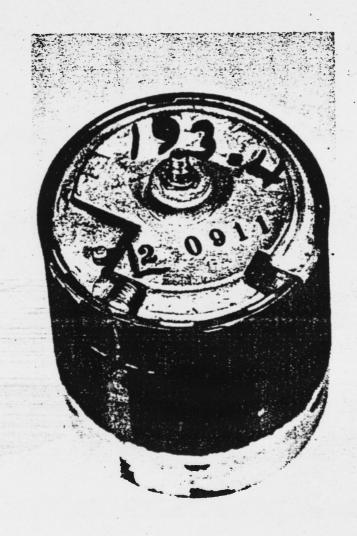
15. After completion of the transportation-vibration test, the sliders for all submunitions were in, the firing pins were extended.	X	X	X	X	
16. Firing pin cap stake failed on submunition 193-4 (fig. 14).	Sat	Sat	X	Sat

Figure 14. Firing pin stake failed

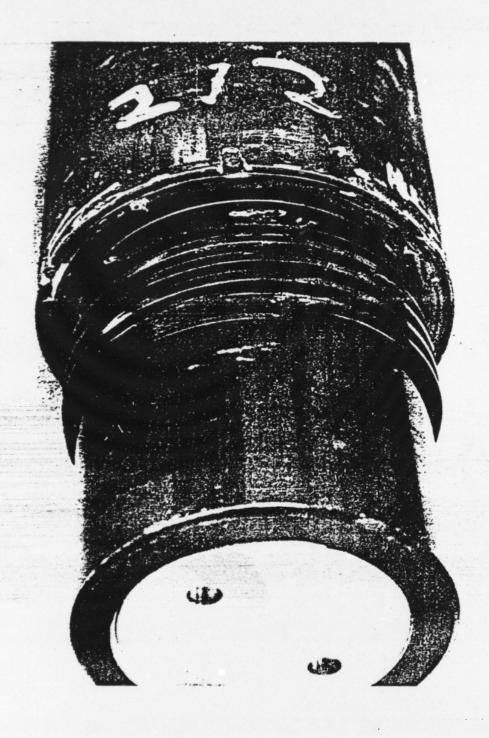
Figure 15. Rd. No. 212. Warhead case pins or rivets sheared and elongated the pinholes in the warhead case assembly after nose down and 45° to nose drops.

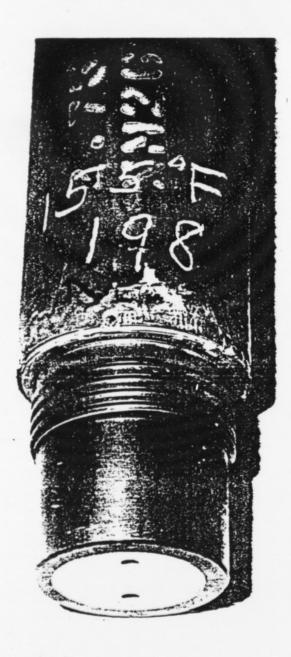
Figure 23. Box 2, 150°F, rd. no. 197 and 198. Warhead case pins or rivets sheared and/or elongated the pinholes in the warhead case assembly (PN 9334131) after the nose down and 45° to base down drops.
